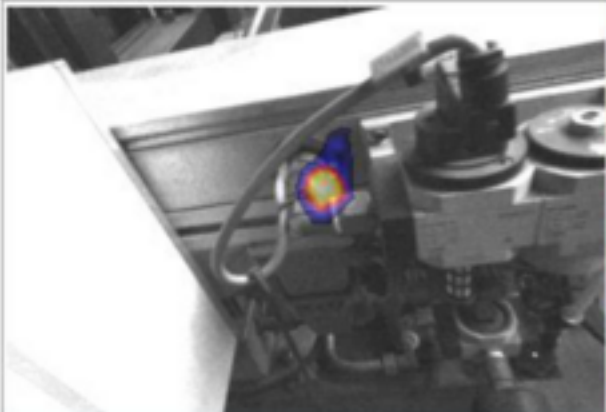
ID	10 (TDMS Dateiname).tdms	Attribute	Value

Loss (GBP/a)	1,83	
	Leak rate (cfm)	0,00	
	Level (dB)	51,7	
	Pressure (psi)	87	
	Distance (ft)	0,69	
	Gas type	Air	
	Machine	C-14	
	Component	W-Einheit	
	Priority	4	
	Repair recommended	Yes	
	Repair done	Yes	
	Repairman	Müller	
Repair date	02.02.2022		
Comment Teflonband erneuern

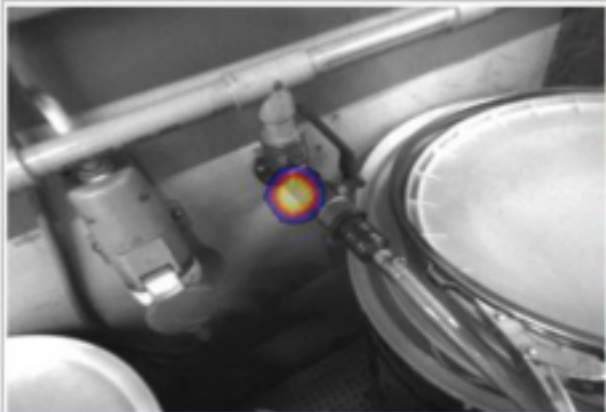
ID	11.tdms	Attribute	Value

Loss (GBP/a)	13,07	
	Leak rate (cfm)	0,03	
	Level (dB)	67,5	
	Pressure (psi)	87	
	Distance (ft)	0,95	
	Gas type	Air	
	Machine	Lack 22	
	Component	M 12	
	Priority	3	
	Repair recommended	Yes	
	Repair done	No	
	Repairman		
Repair date			
Comment Absperrung erneuern
